The Value of Alpha SPF Roofing: An Alpha Case Study at William Lipscomb Elementary School

Case Study at William Lipscomb Elementary

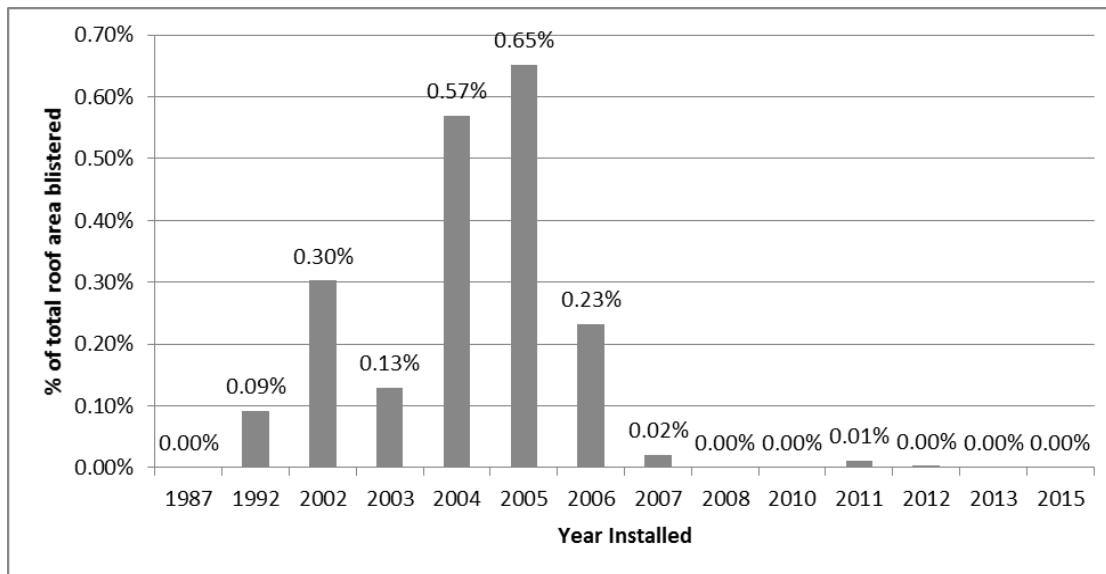
Figure 1: Yearly roof analysis showing blistered percentages of roofs (Zulanas, 2017).

tracking of time and cost deviations, and third party inspection. Figure 1 shows the lack of quality of installation based on the percentage of roof area blistered.

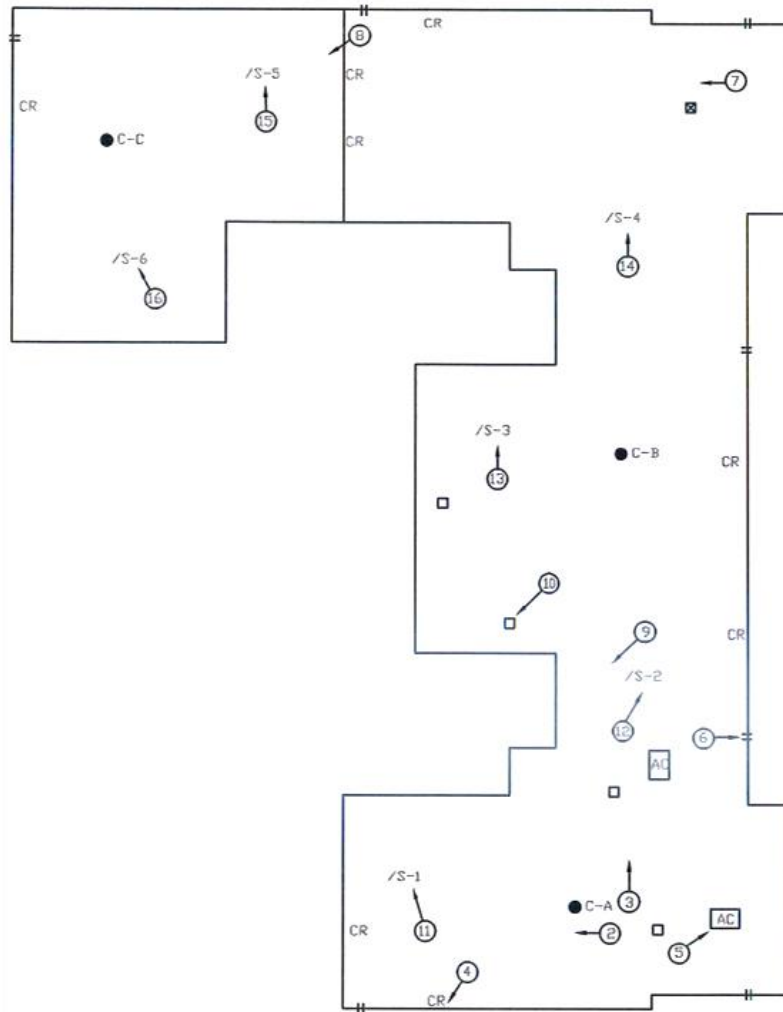
Figure 4: Map of William Lipscomb Roof with Core and Slit Samples (not to scale).

Location of core and slit samples on William Lipscomb Roof are indicated at C-A, C-B, and C-C (see Figure 4). The locations where the slit samples were taken are indicated at S-1, S-2, S-3, S-4, S-5, and S-6. The numbers 1 through 16 that are circled are the specific areas where the third-party inspector took a picture for their report, and the arrow from the numbered circle indicates the direction the picture was taken.

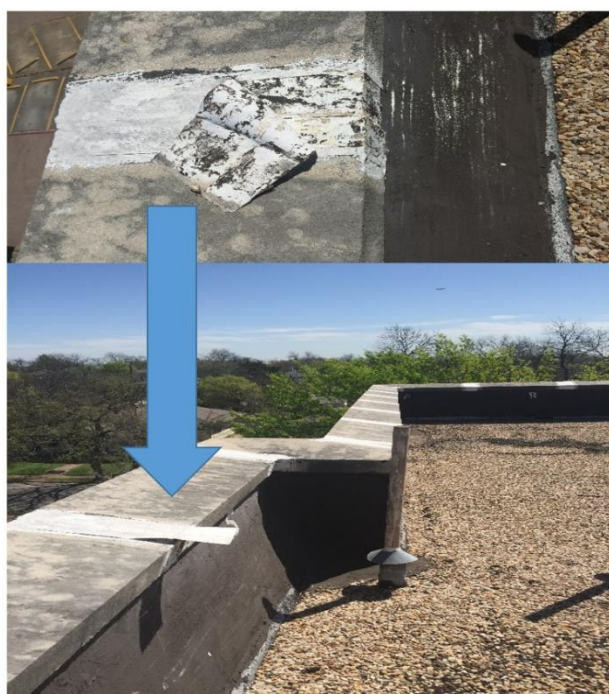
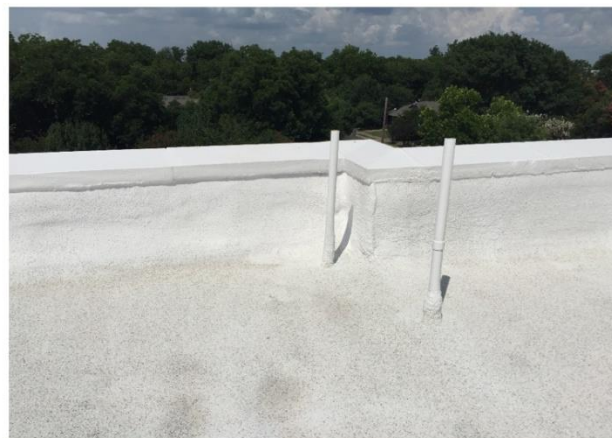
Left Top Picture is part of the ledge that is underneath the flap.
