Hail Study on a 15 Year Old Sprayed Polyurethane Foam Roofing System

Dean Kashiwagi, (PhD, PE), Dhaval Gajjar, (PhD), Jacob Kashiwagi, (PhD) and Kenneth Sullivan (PhD)
Arizona State University
Tempe, AZ, USA

Inspection of the Fosters ES Roof

Roof Name: Stephen Fosters ES
 Location: 3700 Clover Ln, Dallas, TX 75220
 Job Area: 50,754 SF
 Year Installed: October 2002

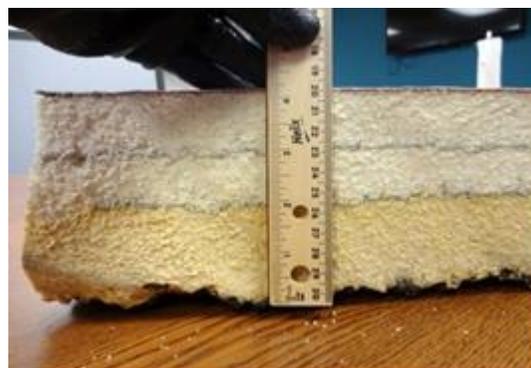
Figure 2: Three Layers of SPF (4” thickness).

The American Society for Testing and Materials (ASTM) Test D-1621 is used to measure the compressive strength and the density of the SPF. A sample from the roof was collected and analyzed. Five tests were performed for each SPF sample for a total of 15 tests for three layers of SPF. The three layers of SPF are as follows with 4” total thickness (figure 2).

- Bottom layer: Old, yellow foam materials (2” thick).
- Middle Layer: New SPF material (1” thick).
- Top Layer: New SPF material (1” thick).

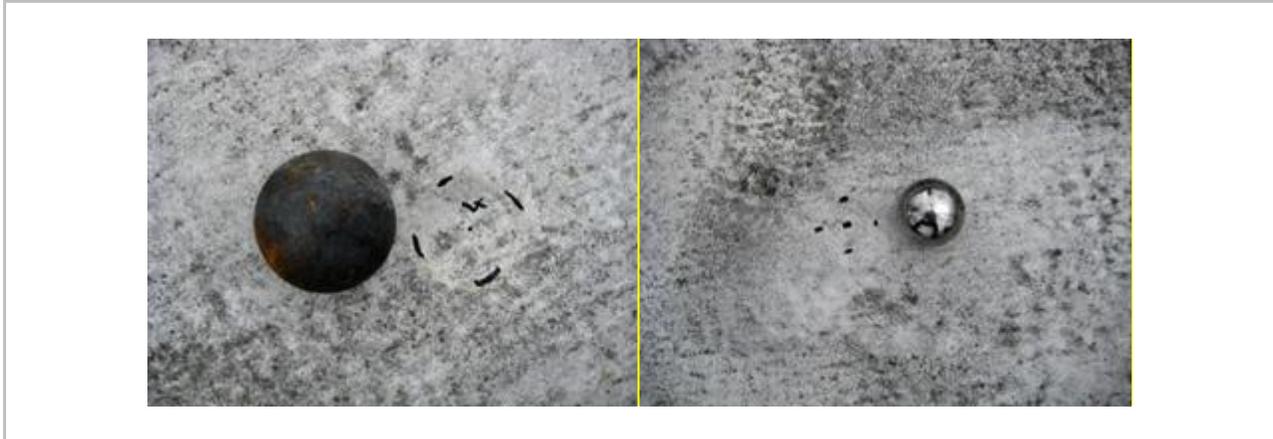
Figure 3: Indentations - 4” and 2” steel ball.

Measurements were taken after the tests were performed to determine the impact depth and impact diameter of the 2” steel ball and 4” steel ball (figure 3).

Table 2 provides a detailed analysis of the impact depth and impact diameter of the hail drops. The average impact width for 2” steel ball and 4” steel ball were 1.5” and 3.5” respectively whereas the average impact depth for 2” steel ball and 4” steel ball was 0.193” and 0.388” respectively.

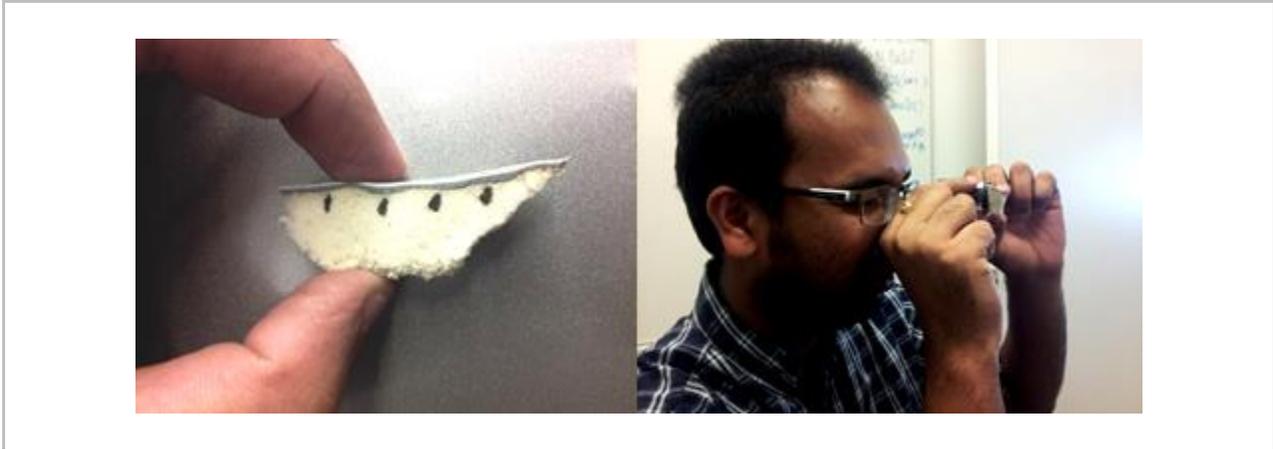
Figure 4: Slit Sample Mil Thickness.

Slit samples were taken on the roofs to determine the average coating thickness of the in-place systems (figure 4). Sixteen (16) total slit samples were taken from the dropped locations. Four (4) measurements per sample were taken to determine the average thickness of the sample (64 total measurements).

The average coating thickness and the minimum coating thickness were measured on each slit sample. The results of the measurements are shown in Table 2a and Table 2b, and indicate that the average mil thickness was 46.25 mils and 44.11 mils for 2” and 4” steel ball drops respectively.

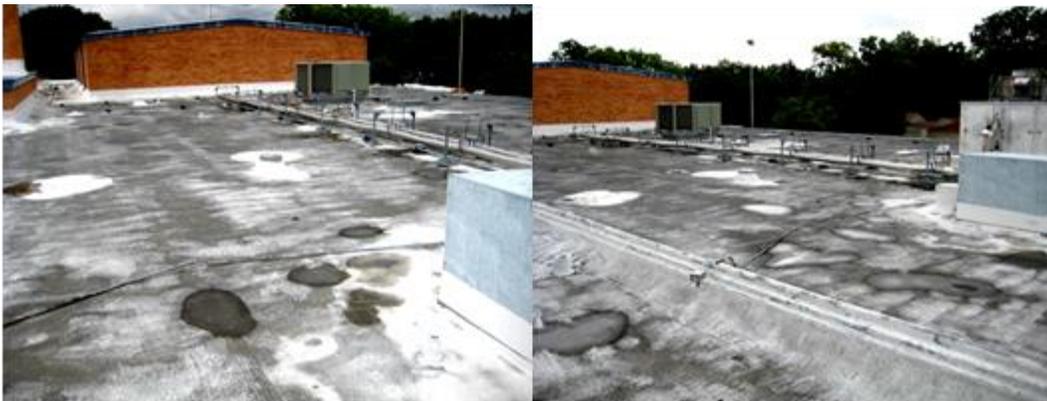
Figure 5: Actual Roof.

- The hail test on the Alpha coating showed no signs of damage.
- Only 1 out of 10 drops of the 4" steel ball (severe hail simulation) resulted in a 1/2" slit.
- The SPF sample had a total thickness of 4", average compressive strength of 50.7 psi and average density of 2.96 PCF (matching new Alpha roof SPF requirements).
- The roof only has 3 SF of blisters (.006% of roof area) and is free of leaks and deterioration.
- Roof is capable of lasting another 15 more years with a simple recoat (resulting in 38 years of performance at a fraction of the cost of a traditional modified roof).
- Roof is being replaced after the hail storms, but there is no visual damage on the roof (figure 5).

The authors conclude that the Alpha SPF roof system should not have been tear-off, but should have been recoated at a cost of \$5.00/SF. The roof would have lasted an additional 15 years, taking the full service period of the roof at 38 years. The roof would have cost DISD less than 50% of the procured BUR system, and would have been a financial windfall. The Fosters Elementary School also shows that the Alpha SPF roof system is a renewable, green roofing system that is an economic alternative to the modified BUR system.
