Best Value Case Study for Cold Storage Facility in Miami, Florida

Dhaval Gajjar, (M.S.), Dean Kashiwagi, (Ph. D.), Jacob Kashiwagi, (Ph. D.), Kenneth Sullivan, (Ph.D.)

Arizona State University
Tempe, AZ, USA

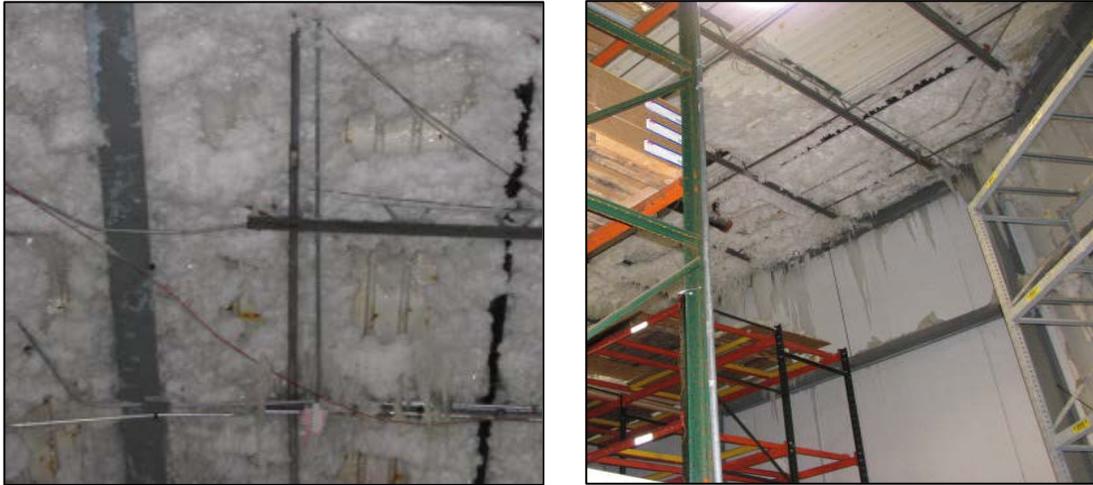
Figure 1: Ice Formations

The facility was reroofed in 2003 to eliminate problems with leaking and ice formation. The specifications were done by an engineering service representing the client. After six years [2009], ice continued to form in the cold storage facility as shown in Figure 1, and the facility management representative perceived that the problem had to be rectified even though it was a recently installed roofing system [six years previous].

After six years, without noticeable deterioration on the exterior roofing system, the cold storage facility was experiencing widespread and dangerous ice formations [as large as five feet in length]. The ice formations caused a safety hazard as well as a potential inefficient electrical usage. The cause of the problem was not immediately known, however, the facility manager representing the building owner along with the tenant proposed that a new roof may be required.

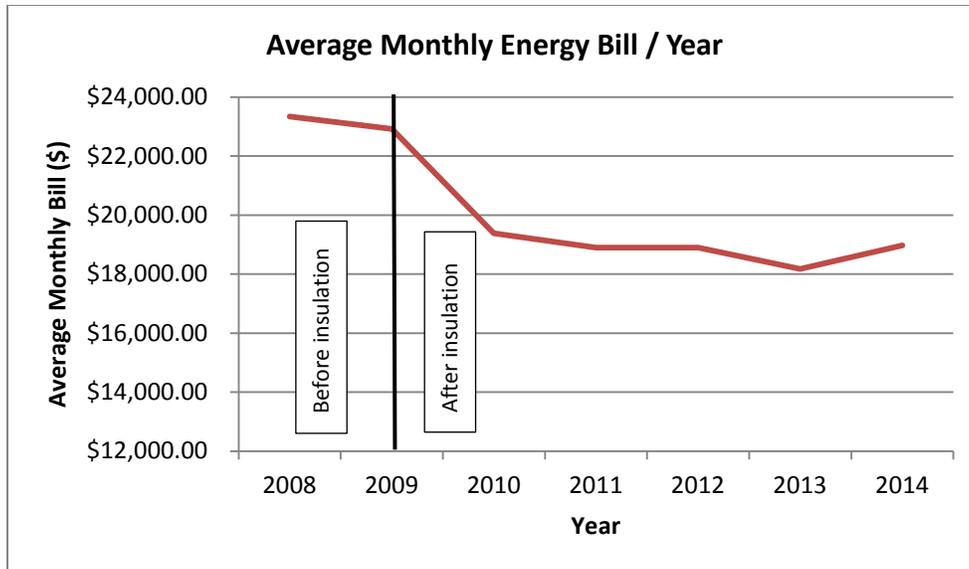
Figure 2: Average Monthly Energy Cost / Year

The roof was insulated in late October 2009. Table 9 shows the energy cost and usage from 2008 to the present. Figure 2 shows that the average monthly bill has decreased since the insulation. Figures are missing from two months. Alumbaugh & Humm (1984) also found significant energy savings by the application of foam insulation in their studying of the long-term weathering performance and the energy savings. However, the study on energy savings for sprayed polyurethane foam insulation has not been determined in the industry.

1. There is no significant deviation in usage or price of energy by month or by year.
2. The average savings in cost per month is 17%.
3. The return on investment is 14 years.
4. The roof is warranted for 15 years. It has been in service for five years and there is no sign of major deterioration.
5. If the roof lasts for the warranted 15 years the energy savings has paid for the roof. The owner has received the roof for free due to the payback in energy savings. The value added is \$650K over 15 years.

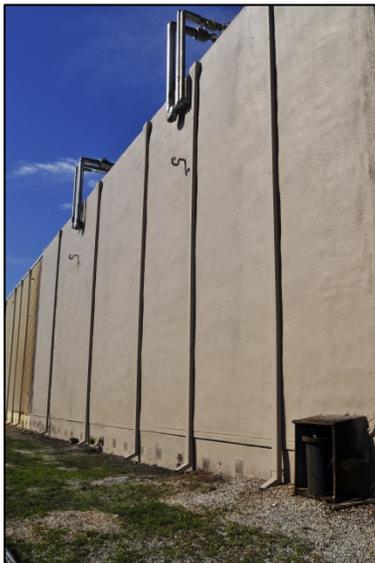
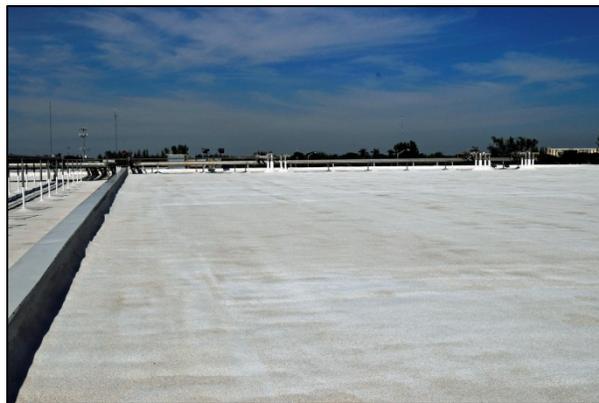
Figure 3: Completed Project

The BV test impressed the owner, the code compliance group, the facility manager and the tenant. The tenant management has been extremely pleased with the performance of the sprayed polyurethane and urethane waterproofing coatings on the wall and roofing system which has minimized the penetration of moisture and ice formation in a temperature differential of up to 130 degrees for over five years. Figure 3 shows the pictures of the wall insulation and the roof insulation after the project completion.
