The Value of Alpha SPF Roofing: An Alpha Case Study at William Lipscomb Elementary School

Case Study at William Lipscomb Elementary

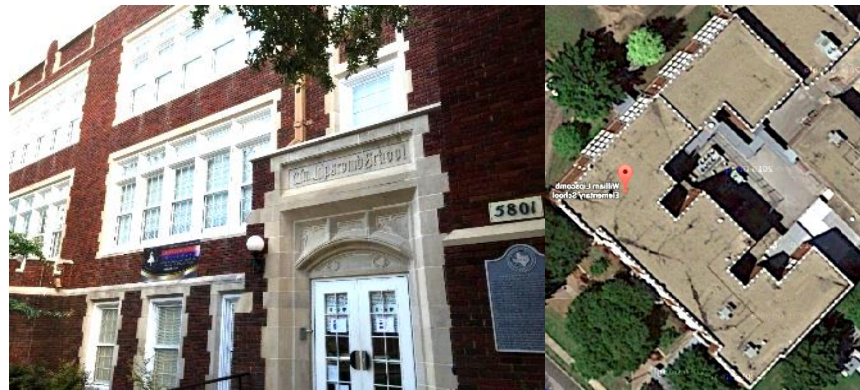
Figure 2: William Lipscomb Elementary School, DISD, Dallas TX.

The William Lipscomb Elementary had a 17,578-square foot built up roof over coal tar pitch with constant leaking problems over its 15+ years of service, see Figure 2 and 3 for pictures and drawings of the roof. The roof included two HVAC units, two 4" vents, miscellaneous plumbing stacks, gas line and one roof hatch. The roof hatch was scheduled to be screwed shut and foamed over. One of the reasons for utilizing the SPF roof system was savings of over \$100,000 versus the removal of the existing system and installing the more traditional MB roof. The Alpha SPF roof may also extend the service life up to 45 years after two recoats of SPF, as was seen from the performance information on Alpha roofs installed at Casa View and Foster's Elementary school (Kashiwagi 2016a; Kashiwagi, 2016b).

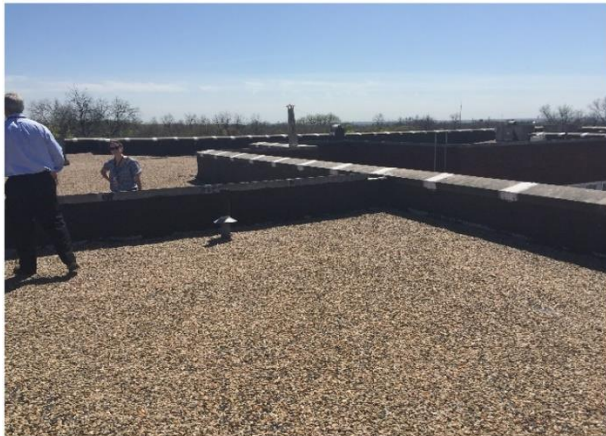
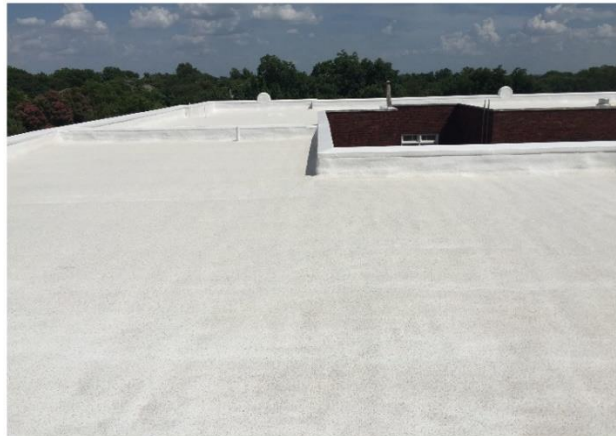
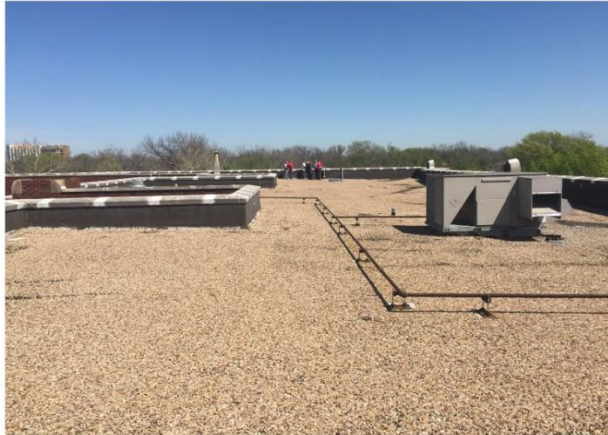
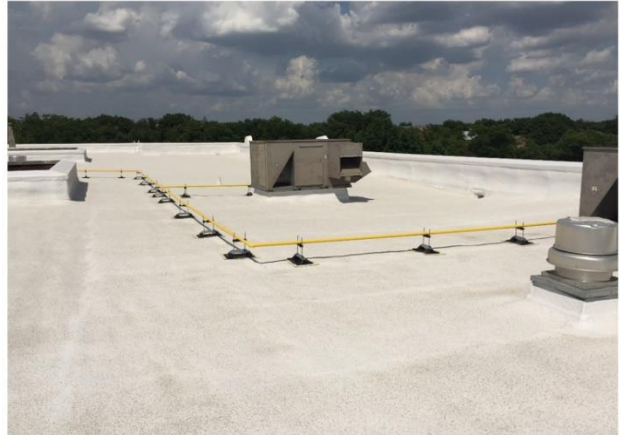
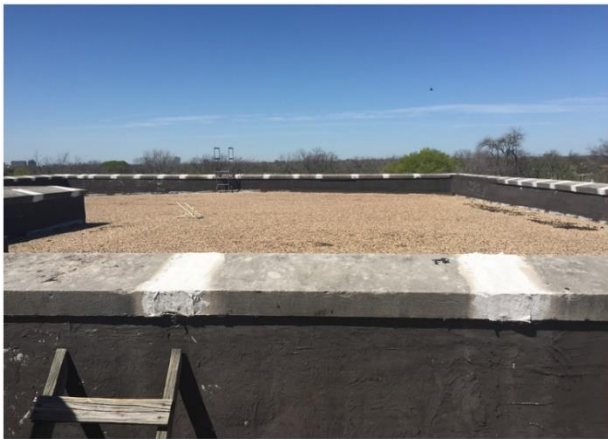
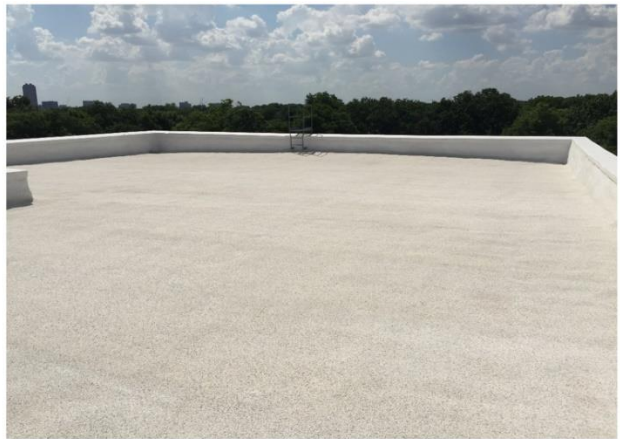
Appendix F: Before and After Pictures of the William Lipscomb Elementary School Roof

For additional proof of the roof installation's quality workmanship, DFWU videotaped the entire roof installation of William Lipscomb High School, clearly demonstrating their expertise. If DFWU had installed the roof improperly, there would have been video evidence that the workmanship was at fault and the contractor would be required to pay for any roof defects. This eased the client's anxiety about the roof installation and clearly showed that the workmanship would not be at fault for any future roof defects. Additionally, DFWU used the video as promotional material for clients to see their expertise and to demonstrate how the SPF application works, not only providing workmanship quality assurance but marketing material for the high performance Alpha contractor as well. Comparative before and after photos of the roof are shown in Appendix F.
