Hail Study on a 15 Year Old Sprayed Polyurethane Foam Roofing System

Dean Kashiwagi, (PhD, PE), Dhaval Gajjar, (PhD), Jacob Kashiwagi, (PhD) and Kenneth Sullivan (PhD)
Arizona State University
Tempe, AZ, USA

Inspection of the Fosters ES Roof

Roof Name: Stephen Fosters ES
 Location: 3700 Clover Ln, Dallas, TX 75220
 Job Area: 50,754 SF
 Year Installed: October 2002

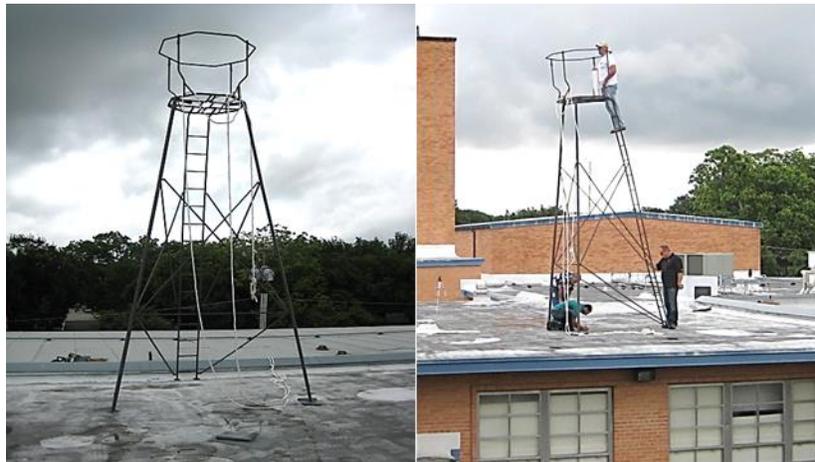
Figure 1: Hail Testing Apparatus.

After setting up and dropping each steel ball, the impact was examined to determine if there were any failures (cracks or tears) in the system. A total of 20 hail drops were performed (10 drops with 2” steel ball and 10 drops with 4” steel ball). Nineteen (19 out of the 20 hail drops) passed the test.
